# **Removal Recommendation**

## **Degradation of Aesthetics Beneficial Use Impairment**

### **St. Marys River Area of Concern**

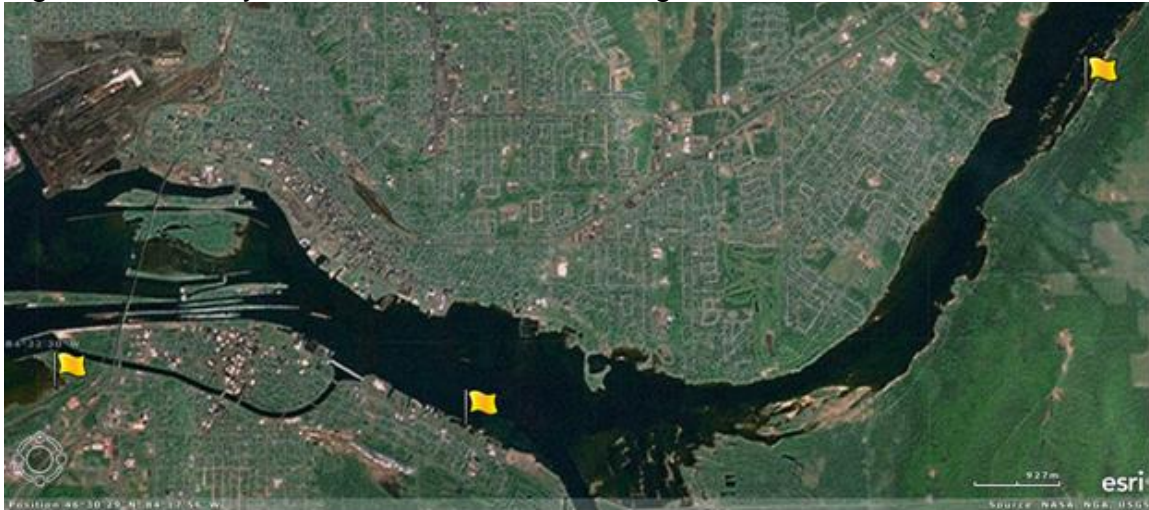
Figure 1: St. Marys River Aesthetics Monitoring Locations

The St. Marys River AOC was assessed on August 3, 2011 and May 23, 2012. See Figure 1 for locations. The goal was to monitor the sites at least once following a significant wet weather event, in order to evaluate the extent and severity of the sanitary trash problem at the Sugar Island township park. While a moderate amount of rain had fallen in the days prior to the August 3<sup>rd</sup> assessment, the monitoring crew only observed one small piece of trash that may have been related to a combined sewer overflow event.

Three sites were assessed from shore, including: Ashmun Bay, the river at the campground behind the Elks Lodge, and the Sugar Island Township park on the north shore of Sugar Island on the US side of the AOC. Minnows, ducks and geese were observed, as were fishermen and evidence of people having fished from shore throughout the assessment areas. Goose droppings littered the beach area at the Sugar Island beach during the 2012 assessment, and a shoe and a bobber may have indicated recreational use at the site. No debris, films, scum, or other conditions were noted in quantities which would interfere with any of the state's designated uses at any of the sites during either of the assessments. A total of approximately 38 photos were taken, and 18 water samples were assessed through both monitoring cycles.
